West Lake Landfill Vicinity

Radiological Survey and Sampling

November 4-6, 2015

Final Report

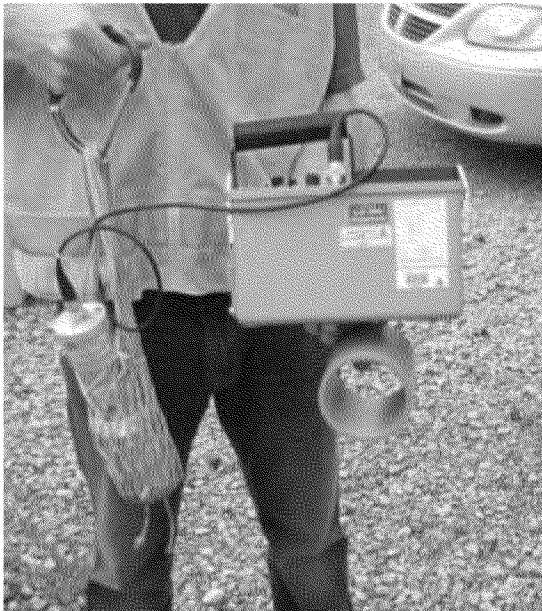
EPA Equipment Y: Ludlum model 2221 with 44-20 NaI Gamma Scintillator detector – This field equipment was brought by and periodically used by EPA personnel at some sampling locations (Photograph 1.)

Photograph 1: EPA Ludlum 2221 with NaI 44-20 detector and directional shield attachment (EPA Equipment Y)

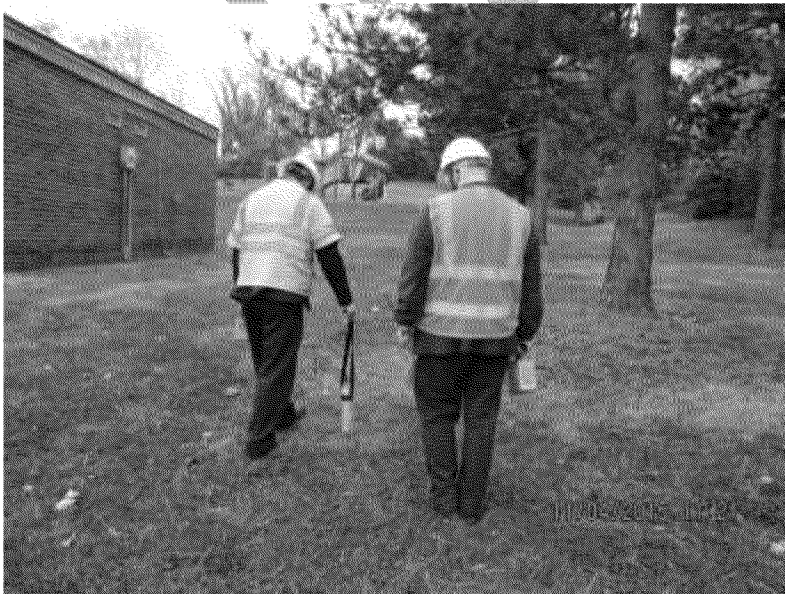
Procedure: For all soil and dust sample locations, equipment B or D was utilized to obtain instantaneous gamma readings where practical at sample areas identified in Figures 1 through 6. Locations within each area identified for soil sampling that had comparatively higher instantaneous readings were flagged for longer scans using equipment B. Some areas were surveyed several times, as shown in Table 4, during this sampling event. Photograph 2 shows an instantaneous gamma survey being conducted at Spanish Village Park.

Photograph 2: Gamma walkover survey conducted at Spanish Village Park

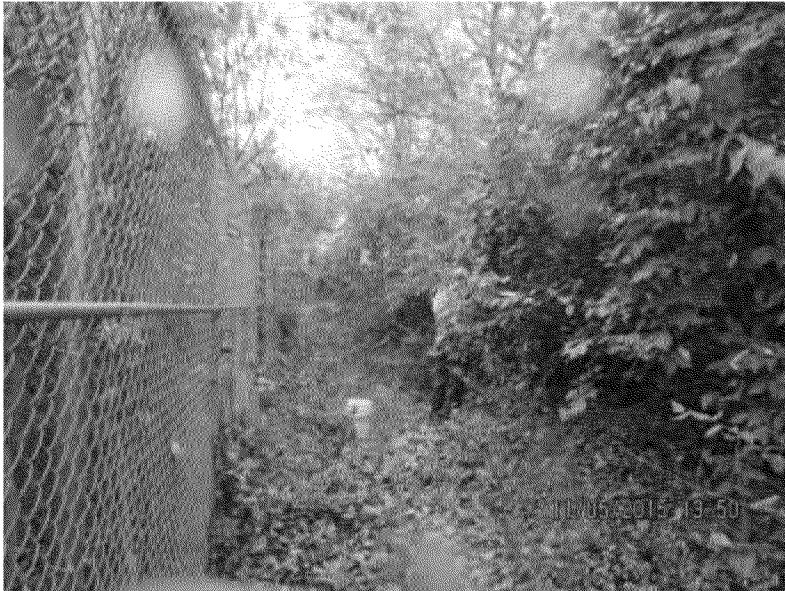
Equipment B: Ludlum model 2221 with 44-10 NaI Gamma Scintillator detector - The meter was utilized to collect instantaneous gamma readings of larger areas (gamma surveys) where practical in order to identify locations with values in the higher range of each area. One-minute readings of each identified location were then collected in order to select each soil and sediment sample location.

Photograph 3: One minute count being conducted on equipment B following gamma survey of immediate area. These locations are flagged in preparation of final soil sample location S09

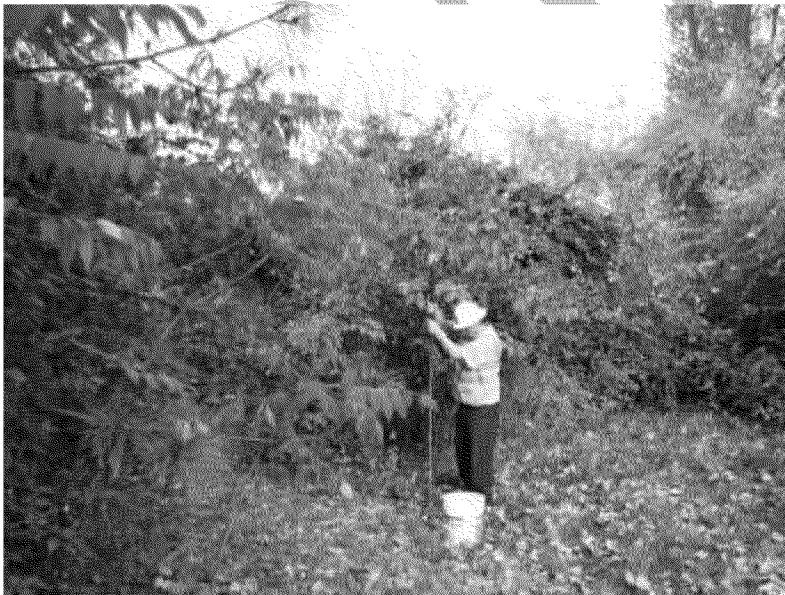
Photograph 4: Soil sampling with Split Spoon sampler

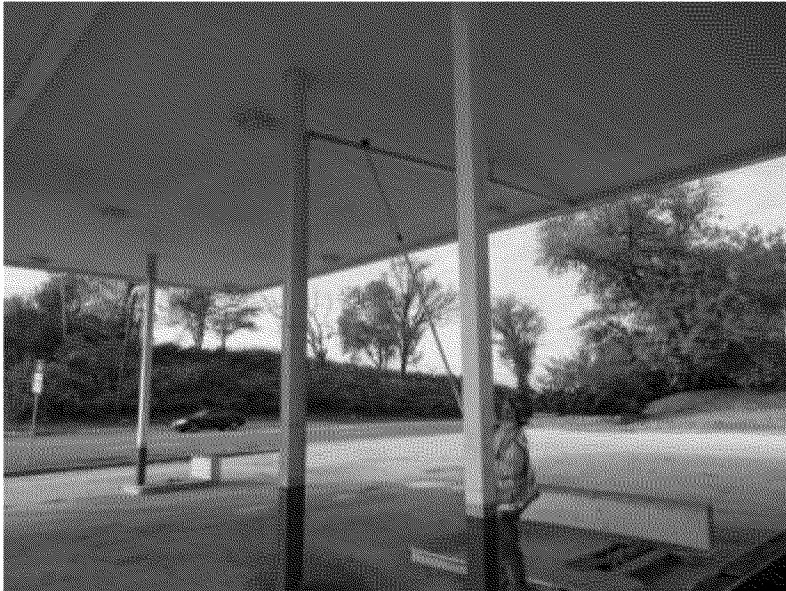
Photograph 7: Collection of dust swipe sample D02A

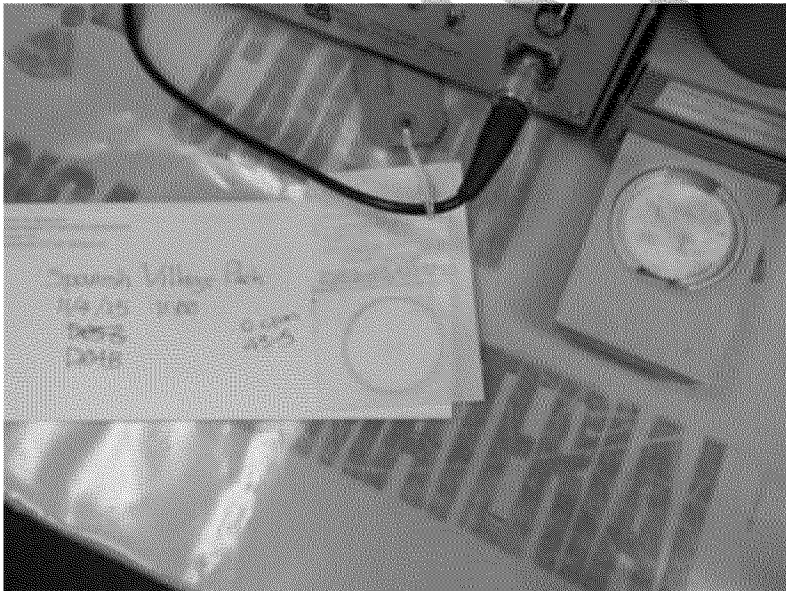
Equipment E: Ludlum model 2929 with 43-10-1 swipe counter - This bench top meter was used to perform alpha counts and combined beta-gamma counts of dust swipe samples. A Thorium 230 check source was periodically used to confirm equipment response.

Photograph 8: Testing of Dust Swipe Sample D04B with Equipment E
